Classic Bearing Damage Modes

Ryan D. Evans, Ph.D.
Manager – Bearing Fundamentals & Tribology
The Timken Company

Wind Turbine Tribology Seminar
NREL-Argonne-DoE
Broomfield, CO, USA
November 2011

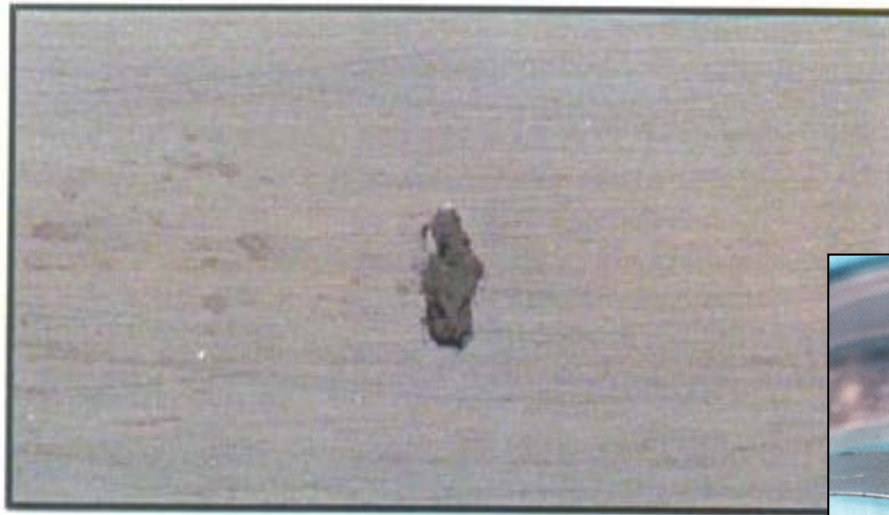
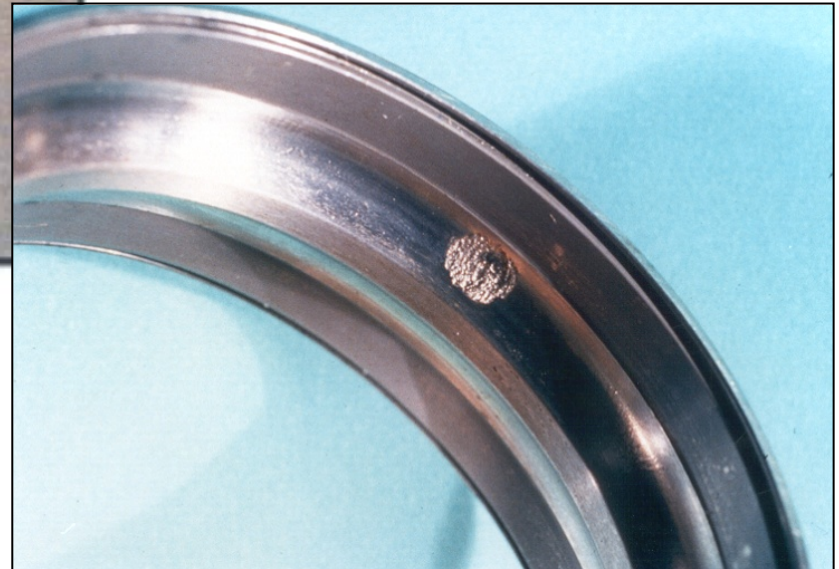
Material Fatigue: Inclusion Origin Spalling

INCLUSION

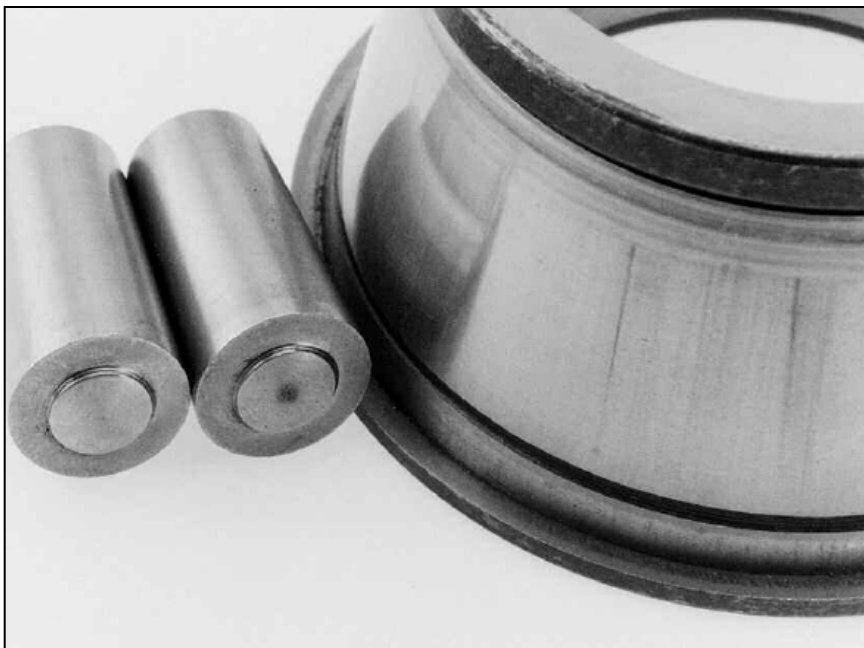
Tapered roller bearing abrasive wear

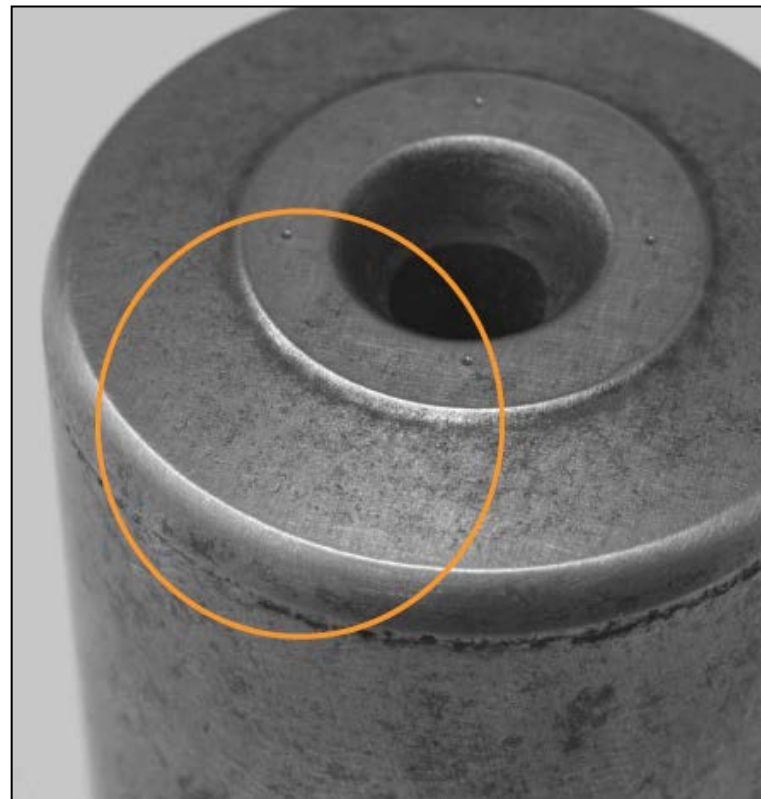
**Spherical roller bearing fine
particle contamination**

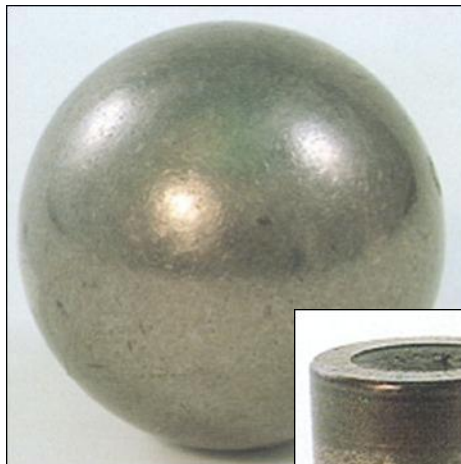
Ball

Debris denting

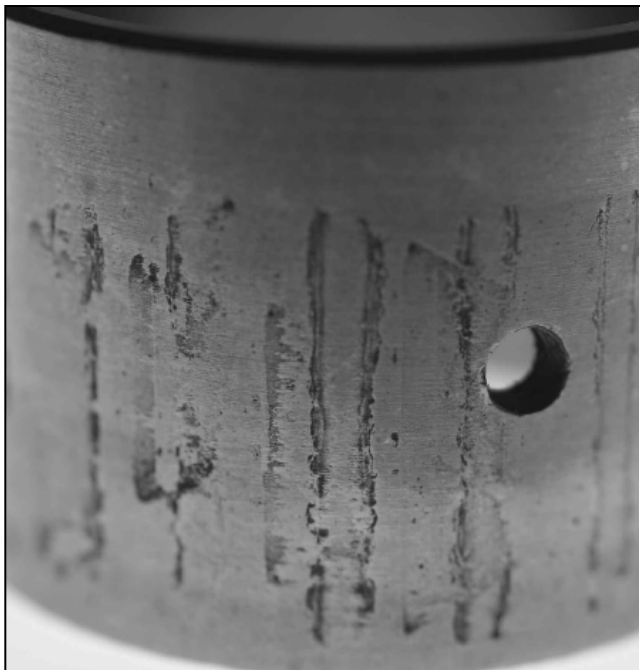
**Etching and corrosion on
cylindrical roller bearing inner ring**

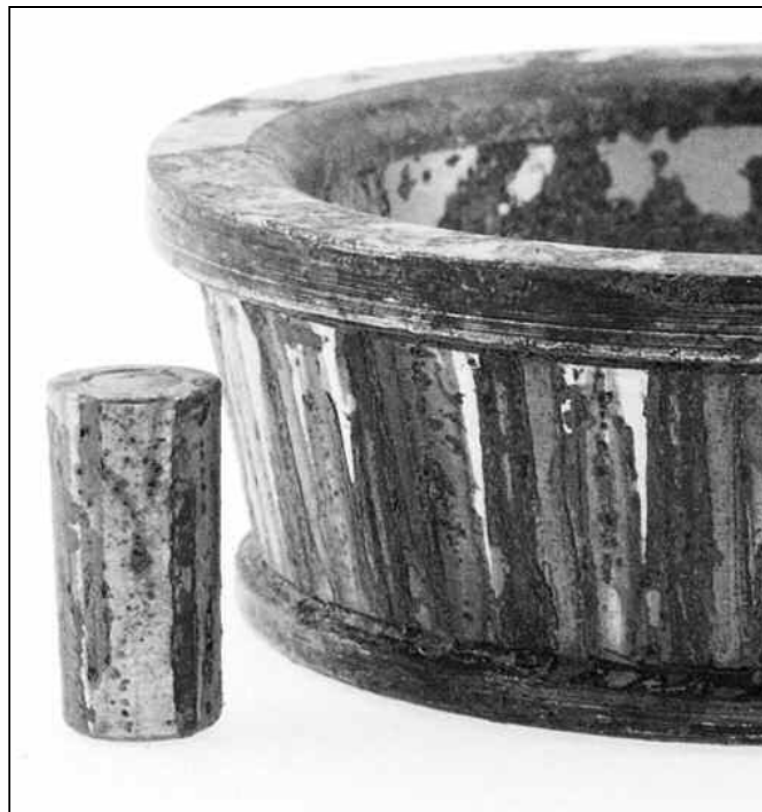
**Advanced corrosion and
pitting on the cone race and
rollers**

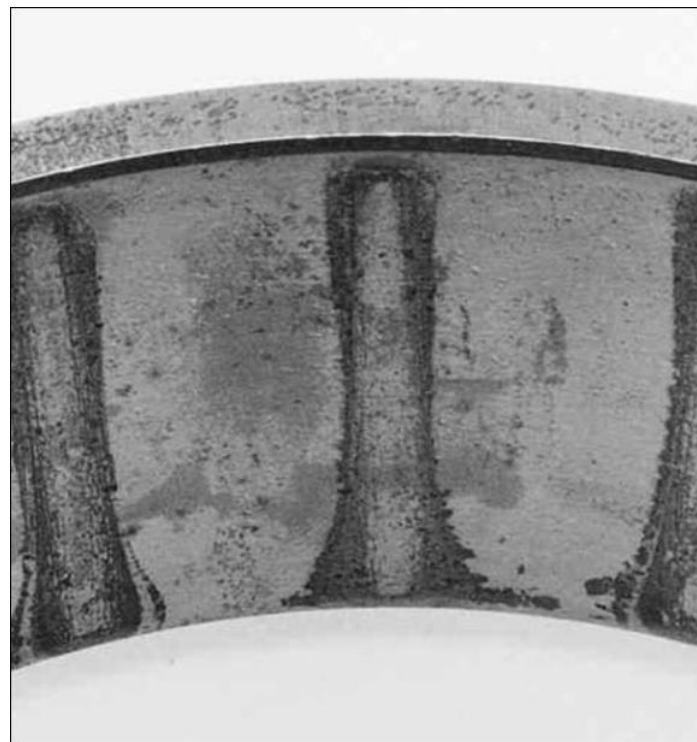
A tapered roller bearing cup with corrosion on the race

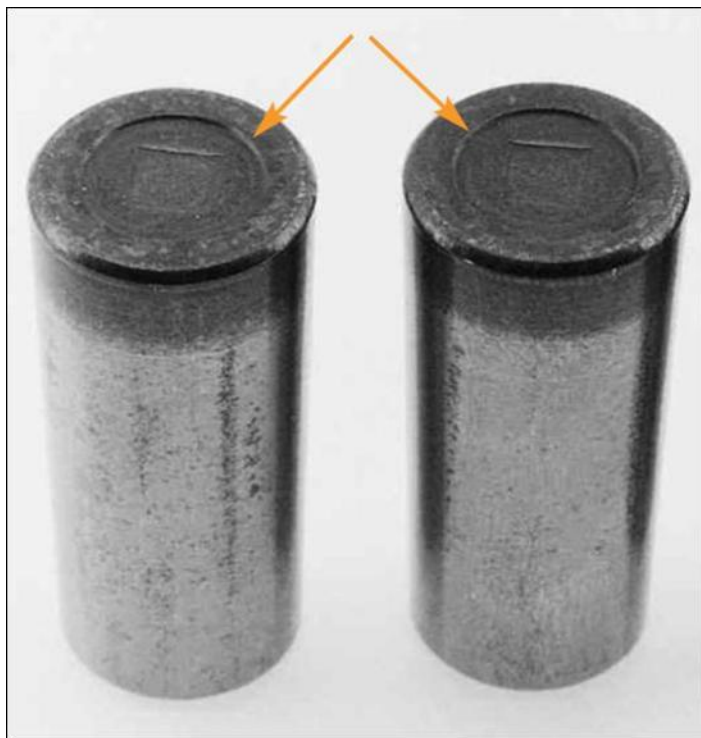
**Heat damage on tapered rollers
from metal-to-metal contact**

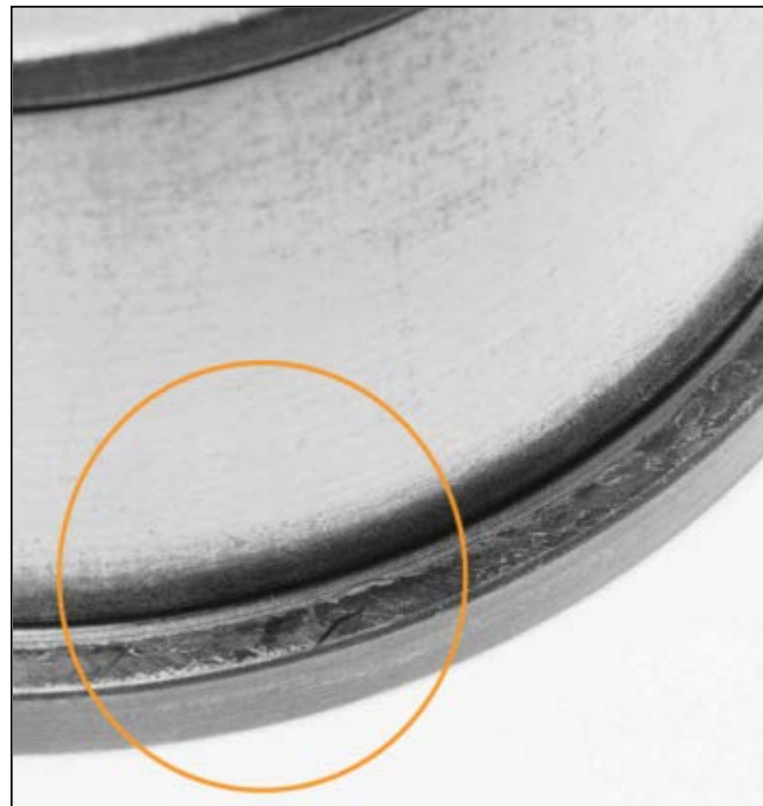
**Scoring of tapered roller ends
and rib face**

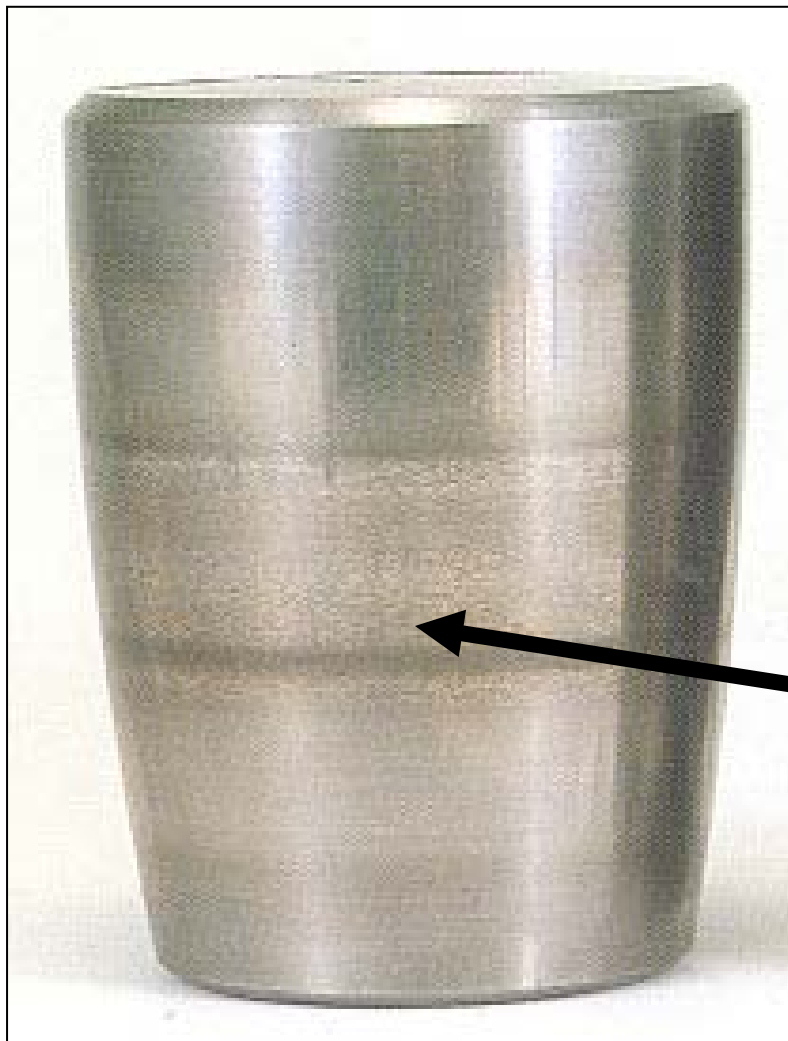
- Thrust SRB Roller with Smearing Damage

Smear bands

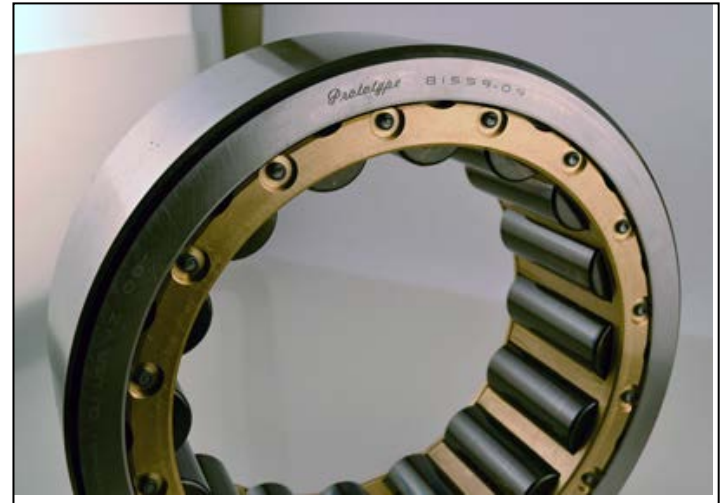
- **T-6411-A cylindrical roller bearing**
 - NU-type.
 - OD = 290 mm, Bore = 160 mm, Width = 98.425 mm
- **(4) test treatments, (3) bearings tested per treatment**

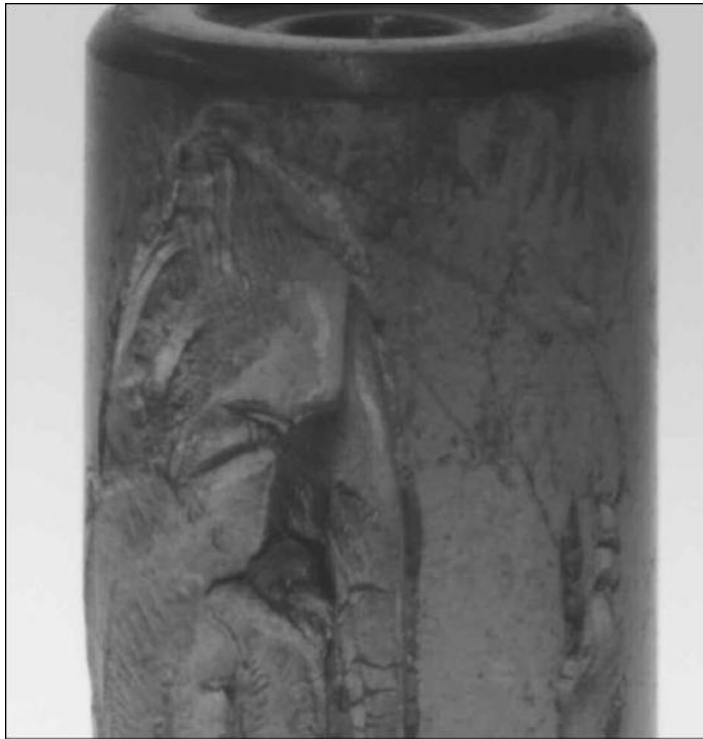
Overloading on a cylindrical roller bearing caused roller surfaces to fracture

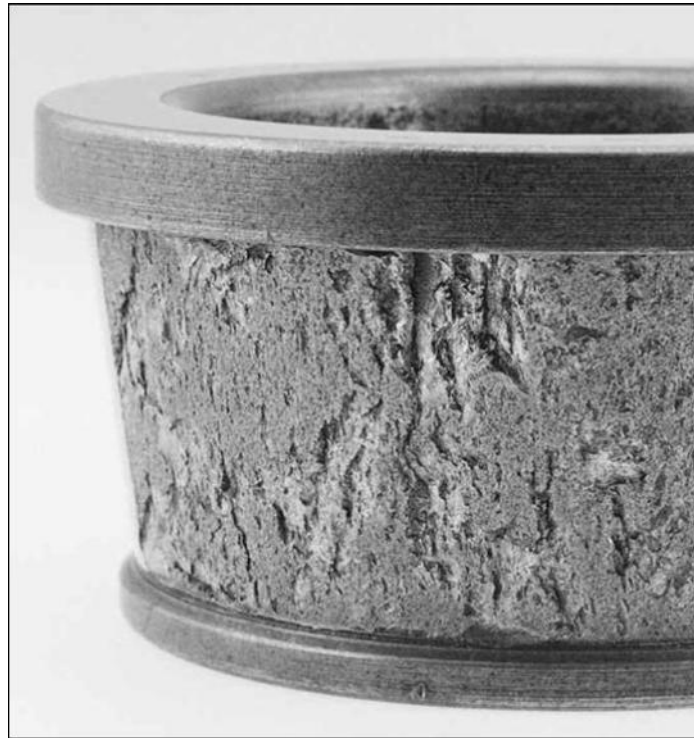
**Overloading and low speed
caused insufficient lubricant film**

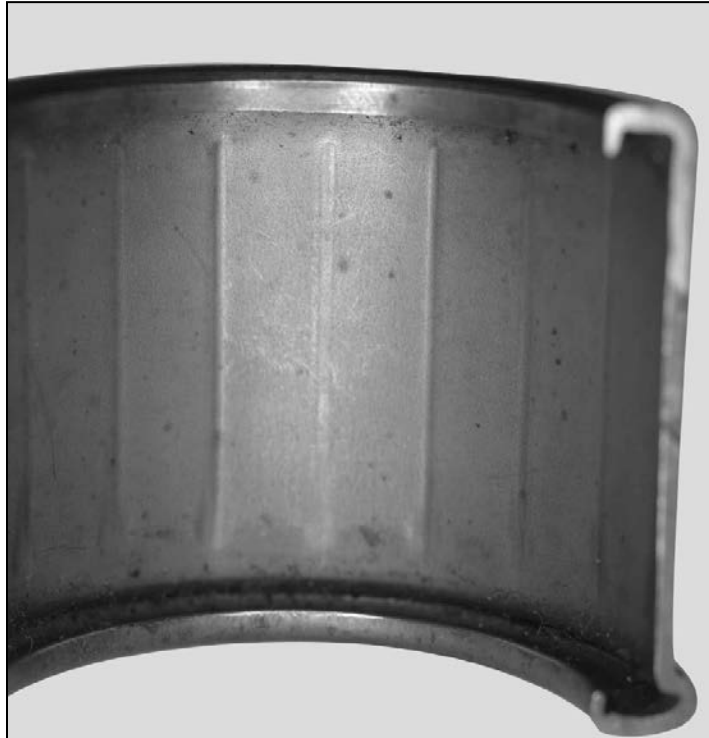
Needle roller bearing outer ring race with roller-spaced indents from impact during installation

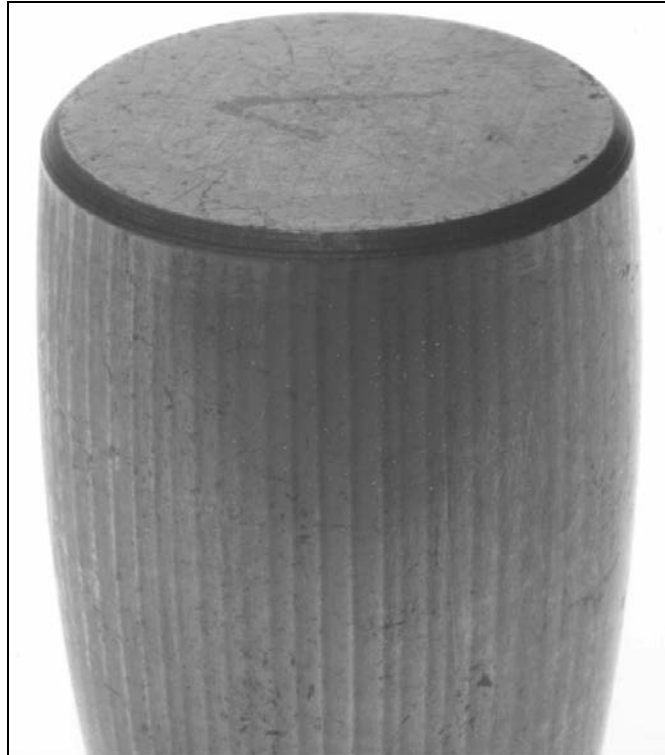
**Roller with fluting caused by welding performed
on machine while bearings were rotating**

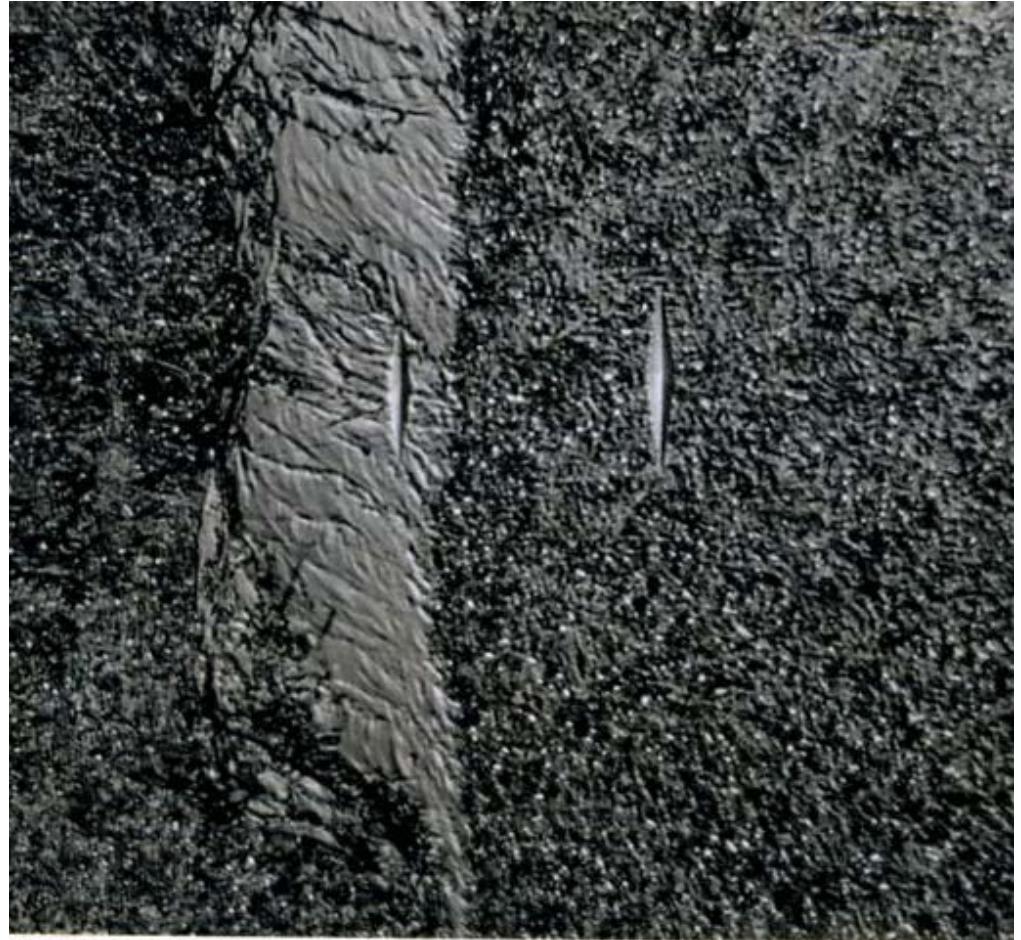
Butterfly – Micro Hardness

- SAE 52100
 - Knoop Hardness
 - Used 25 gram load
 - 3% Nital Etch
 - Originally 800X
 - Nomarski Polarized Lighting
-
- Matrix = 825 KHN = HRC 64
 - Butterfly = 1780 KHN
 >> HRC 70

Source: Torrington Met Lab Archive
